Manhole Inspection Summary

Manhole # S3500_007MH

Insp Date: **1/24/07 1:10 PM**

Location Address: **2300 BARKLEY ST**

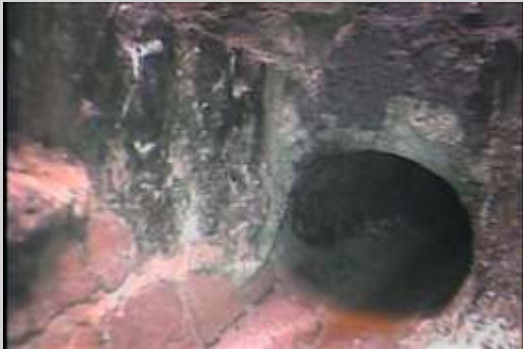
8 in. Circular Gravity Sewer Pipe Out @ 12 O'Clock

Pipe Material: **Clay** ☐ Pipe Lined

Infiltration: **None** Pipe Seal Cond: **Unknown**
